**Flood Control Project Maintenance
Levee Inspections**
LMA District Cover Sheet
Spring 2018 Levee Inspection Results

Reclamation District No. 2095 Paradise Cut

Levee Inspection Report By Mile - Spring 2018

Waterway	Bank	Unit Miles	Inspection Start/End	Inspector
Unit No. 01 Paradise Cut	Left	1.45	05/15/2018 05/15/2018	Zach Jojola

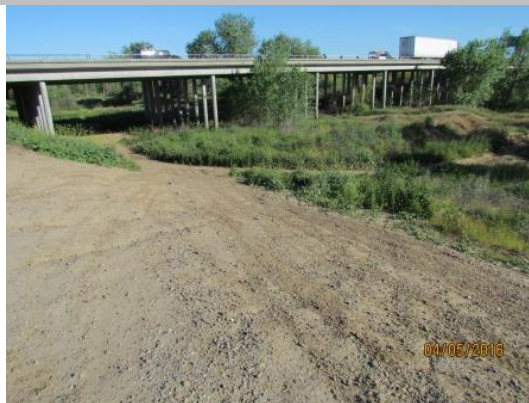
Photo 1 of 1 : SP_2018_RD2095_322_10_20180507_00001.jpg

LM Start	0.15	Rating **	A/W	Issue No.	10
LM End	0.15	Issue Type +	Ma	Location *	WS
Category	Earthen Levee			GPS Latitude/Longitude	
				Start	End
Item	Slope Stability			37.769997 °	37.769997 °
				-121.325055 °	-121.325055 °
DWR ID	DWR_RD2095_01_f_2015_10				
Comment Code					
S3 : Repair the levee slope damaged by vehicle traffic and prevent access where possible.					
Inspector Comment					
LMA is actively controlling access. The slope appears to be stable and should be monitored for possible erosion.

View of the vehicle tracks on the waterside levee slope.

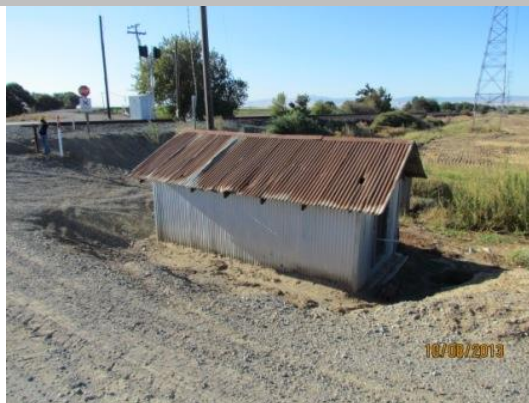
Photo 1 of 1 : SP_2018_RD2095_322_11_20180507_00002.jpg

LM Start	0.71	Rating **	M	Issue No.	11
LM End	0.71	Issue Type +	En	Location *	LS
Category	Earthen Levee			GPS Latitude/Longitude	
				Start	End
Item	Encroachments			37.763630 °	37.763630 °
				-121.319045 °	-121.319045 °
DWR ID	DWR_RD2095_01_s_2012_11				
Comment Code					
BU : Building					
Inspector Comment					
Pump house near RR.

View of building at the landside levee toe.

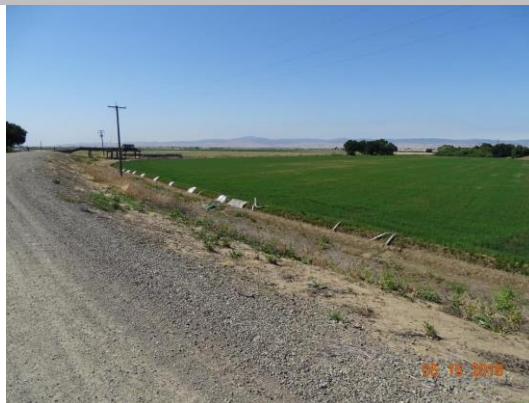
Photo 1 of 1 : SP_2018_RD2095_322_5_20180516_00015.jpg

LM Start	0.78	Rating **	A	Issue No.	5
LM End	1.47	Issue Type +	Ma	Location *	LS
Category	Earthen Levee			GPS Latitude/Longitude	
				Start	End
Item	Vegetation			37.762857 °	37.759172 °
				-121.318371 °	-121.308117 °
DWR ID	DWR_RD2095_01_s_2018_5				
Comment Code					
V1 : Control annual grass and weeds on the levee slopes and easements.					
Inspector Comment					
LMA is doing an excellent job maintaining their vegetation.

View of well-maintained landside slope. Spring 2018.

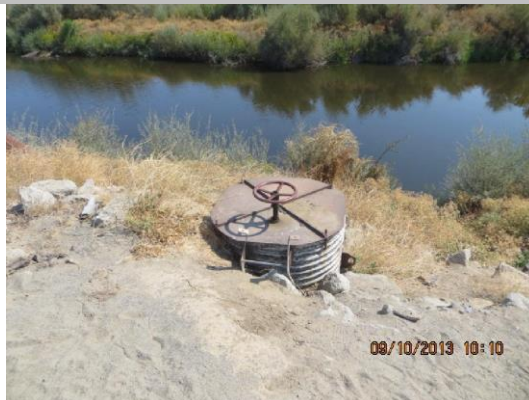
Photo 3 of 3 : UCIP_SP_2018_34387_62271.jpg

Slide gate in 48-inch CMP riser on WS shoulder.

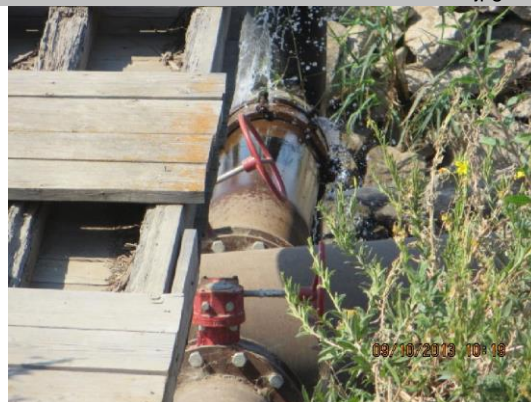
Photo 3 of 3 : UCIP_SP_2018_19813_33713.jpg

Butterfly valve at pump on LS toe.

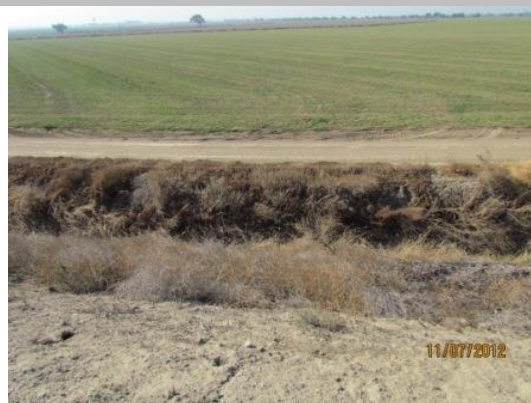
Photo 1 of 1 : SP_2018_RD2095_323_5_20180507_00006.jpg

LM Start	0.36	Rating **	M	Issue No.	5
LM End	0.82	Issue Type +	En	Location *	LS
Category	Earthen Levee			GPS Latitude/Longitude	
				Start	End
Item	Encroachments			37.754952 °	37.749645 °
				-121.305880 °	-121.301977 °
DWR ID	DWR_RD2095_02_f_2012_5				
Comment Code					
DT : Ditch					
Inspector Comment

View of a ditch along the landside toe.

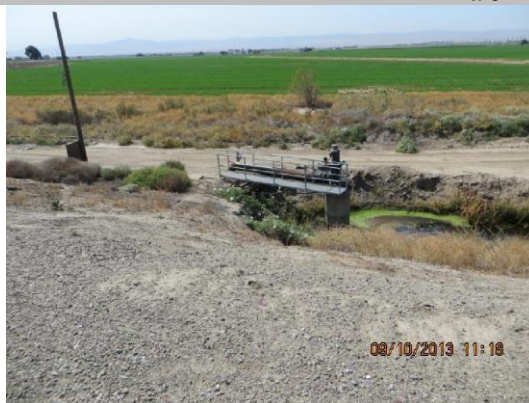
Photo 1 of 3 : UCIP_SP_2018_19866_33767.jpg

LM Start	1.63	Rating **	M	Issue No.	943
LM End	1.63	Issue Type +	En	Location *	
Category	Supplemental			GPS Latitude/Longitude	
				Start	End
Item	DWR UCIP Field Study			37.741345 °	37.741345 °
				-121.296189 °	-121.296189 °
DWR ID					
Comment Code					
Inspector Comment					
FS_ID:19866 DS_ID:21654 EP_NO: 6298A Repair Type: Non-Urgent Crossing Status: Found UCIP Comments: No permit identified for this crossing. FIELD_STRUCT_DESC: 16-inch steel drainage pipe through the levee 2-feet below the crown. Siphon breaker in PVC riser on WS shoulder. Pump on pier in ditch on LS toe 750-feet to Northwest from crossing. FS Date: 9/10/2013

Pump located at levee toe 750-feet north west of pipe crossing.

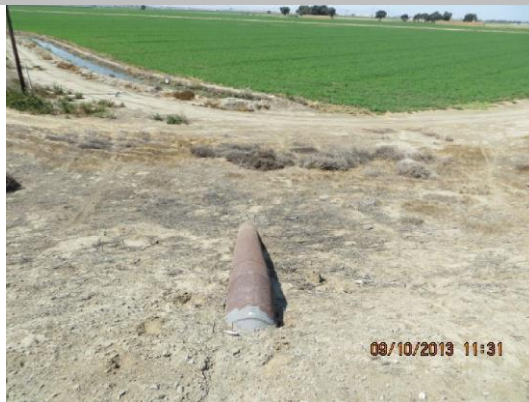
Photo 2 of 3 : UCIP_SP_2018_19866_33766.jpg

16-inch steel pipe on LS slope.

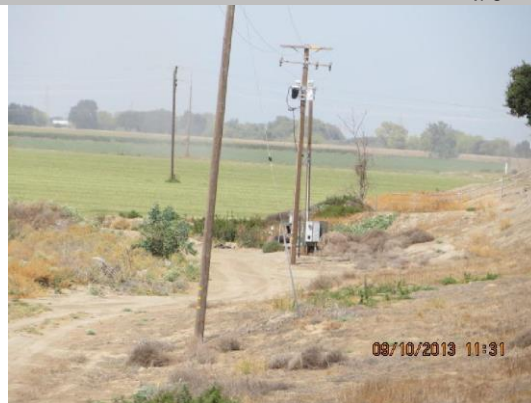
Photo 3 of 3 : UCIP_SP_2018_19866_33765.jpg

LM Start	1.63	Rating **	M	Issue No.	943 (cont)	
LM End	1.63	Issue Type +	En	Location *		
Category	Supplemental			GPS Latitude/Longitude		
				Start		End
Item	DWR UCIP Field Study			37.741345°		37.741345°
				-121.296189°		-121.296189°
DWR ID						
Comment Code						
Inspector Comment						
FS_ID:19866						
DS_ID:21654						
EP_NO: 6298A						
Repair Type: Non-Urgent						
Crossing Status: Found						
UCIP Comments: No permit identified for this crossing.						
FIELD_STRUCT_DESC: 16-inch steel drainage pipe through the levee						
2-feet below the crown. Siphon breaker in PVC riser on WS shoulder.						
Pump on pier in ditch on LS toe 750-feet to Northwest from crossing.						
FS Date: 9/10/2013

Pump located at levee toe 750-feet north west of pipe crossing.

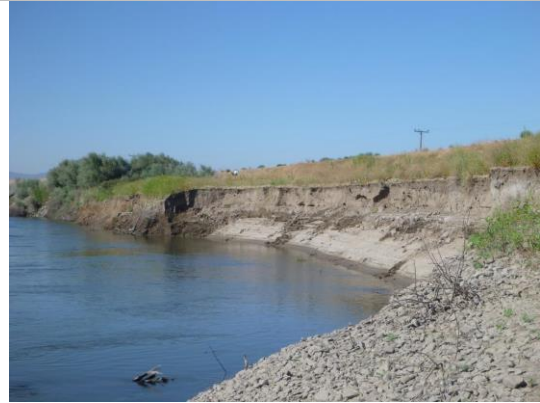
Photo 3 of 3 : LEVAL_SP_2018_469_2353.jpg

Comment Code						
Inspector Comment						
Levee Evaluation Comments						
Description:Active waterside erosion on san joaquin river near the end of Wright Road in Tracy, CA. Total length of erosion extends 615. Erosion has extended 15 feet towards levee toe this flood season. Pleasee see attached map and photots. As the high water level receds from the winter storm, we can see more damage to this stie. Erosion is active.						
Site ID No:469						
Site Designation:LMA-296						
Repair Type: Erosion						
Rating:Serious						
Field Date:7/26/2017						
Notes: This is an active erosion site. Zero vegetation within the eroded portion. It may not be quite in the prism now, but lost about 20 ft (horizontally) of bank last year. Saw eddies in the water here also.

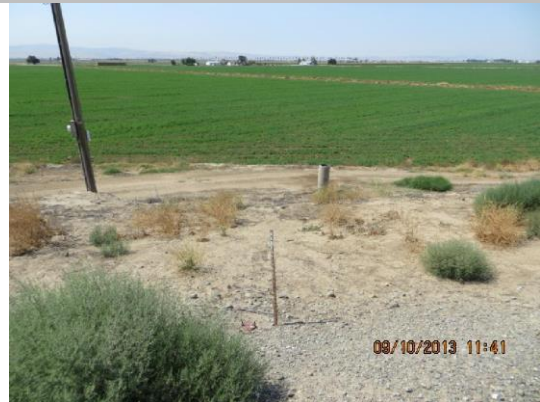
Photo 1 of 3 : UCIP_SP_2018_19867_33771.jpg

LM Start	2.08	Rating **	M	Issue No.	944
LM End	2.08	Issue Type +	En	Location *	
Category	Supplemental			GPS Latitude/Longitude	
				Start	End
Item	DWR UCIP Field Study			37.735416 °	37.735416 °
				-121.297860 °	-121.297860 °
DWR ID					
Comment Code					
Inspector Comment					
FS_ID:19867 DS_ID:21643 EP_NO: N/A Repair Type: Non-Urgent Crossing Status: Found UCIP Comments: Siphon breaker on LS shoulder does not appear to be functional. FIELD_STRUCT_DESC: 16-inch steel irrigation pipe through the levee, 2 feet below the crown. Slant pump on steel platform on the waterside (WS) slope. Siphon breaker on the landside (LS) shoulder marked by a T-post. Service pole and meter on the LS toe. Possible concrete standpipe on the LS toe. [Additional Reference(s): DWR Levee Log, 2005. USACE San Joaquin O&M Manual 11, 1968, (HLM 2.12)]. FS Date: 9/10/2013

Siphon breaker on LS shoulder next to T-post with Power pole and concrete standpipe on LS toe.

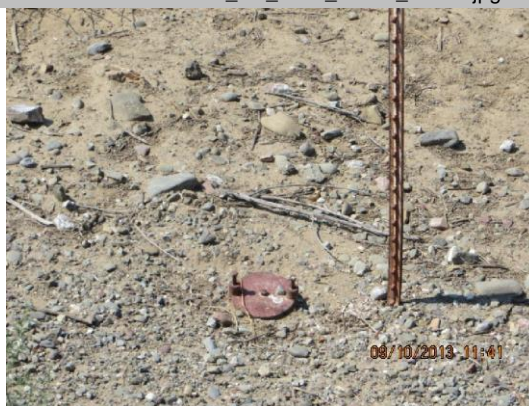
Photo 2 of 3 : UCIP_SP_2018_19867_33770.jpg

Comment Code						
Inspector Comment						
FS_ID:19867						
DS_ID:21643						
EP_NO: N/A						
Repair Type: Non-Urgent						
Crossing Status: Found						
UCIP Comments: Siphon breaker on LS shoulder does not appear to be functional.						
FIELD_STRUCT_DESC: 16-inch steel irrigation pipe through the levee, 2 feet below the crown. Slant pump on steel platform on the waterside (WS) slope. Siphon breaker on the landside (LS) shoulder marked by a T-post. Service pole and meter on the LS toe. Possible concrete standpipe on the LS toe. [Additional Reference(s): DWR Levee Log, 2005. USACE San Joaquin O&M Manual 11, 1968, (HLM 2.12)].						
FS Date: 9/10/2013

Siphon breaker on LS shoulder next to T-post.

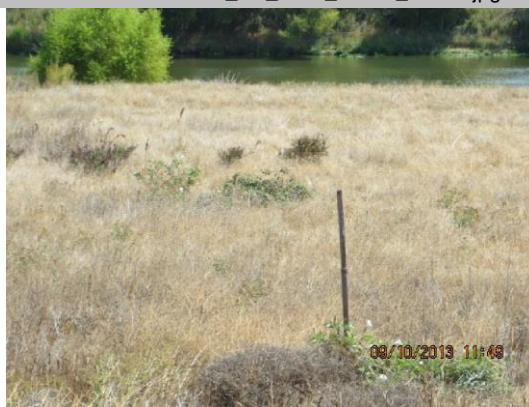
Photo 2 of 2 : UCIP_SP_2018_19871_33777.jpg

Vent standpipe on WS toe.
